**Commercial
building in
Comstock, Nevada
gets new Thermo-
shield Roof**

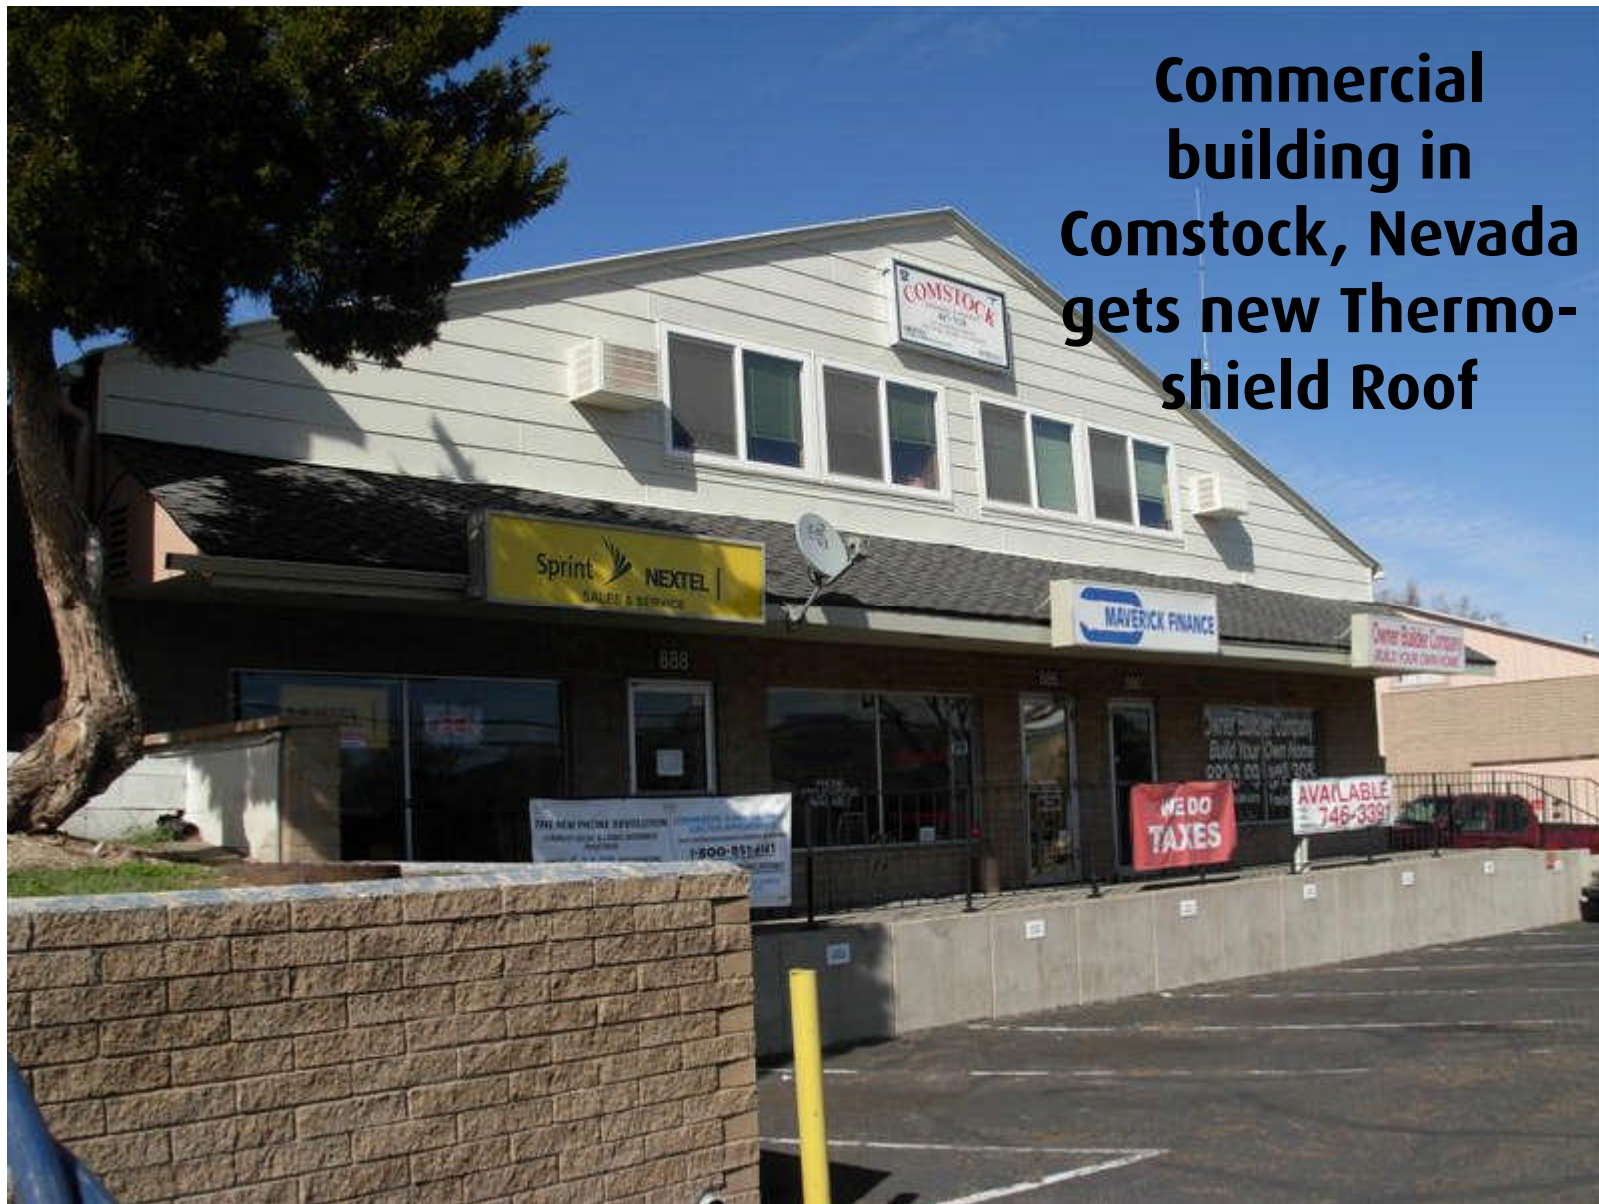
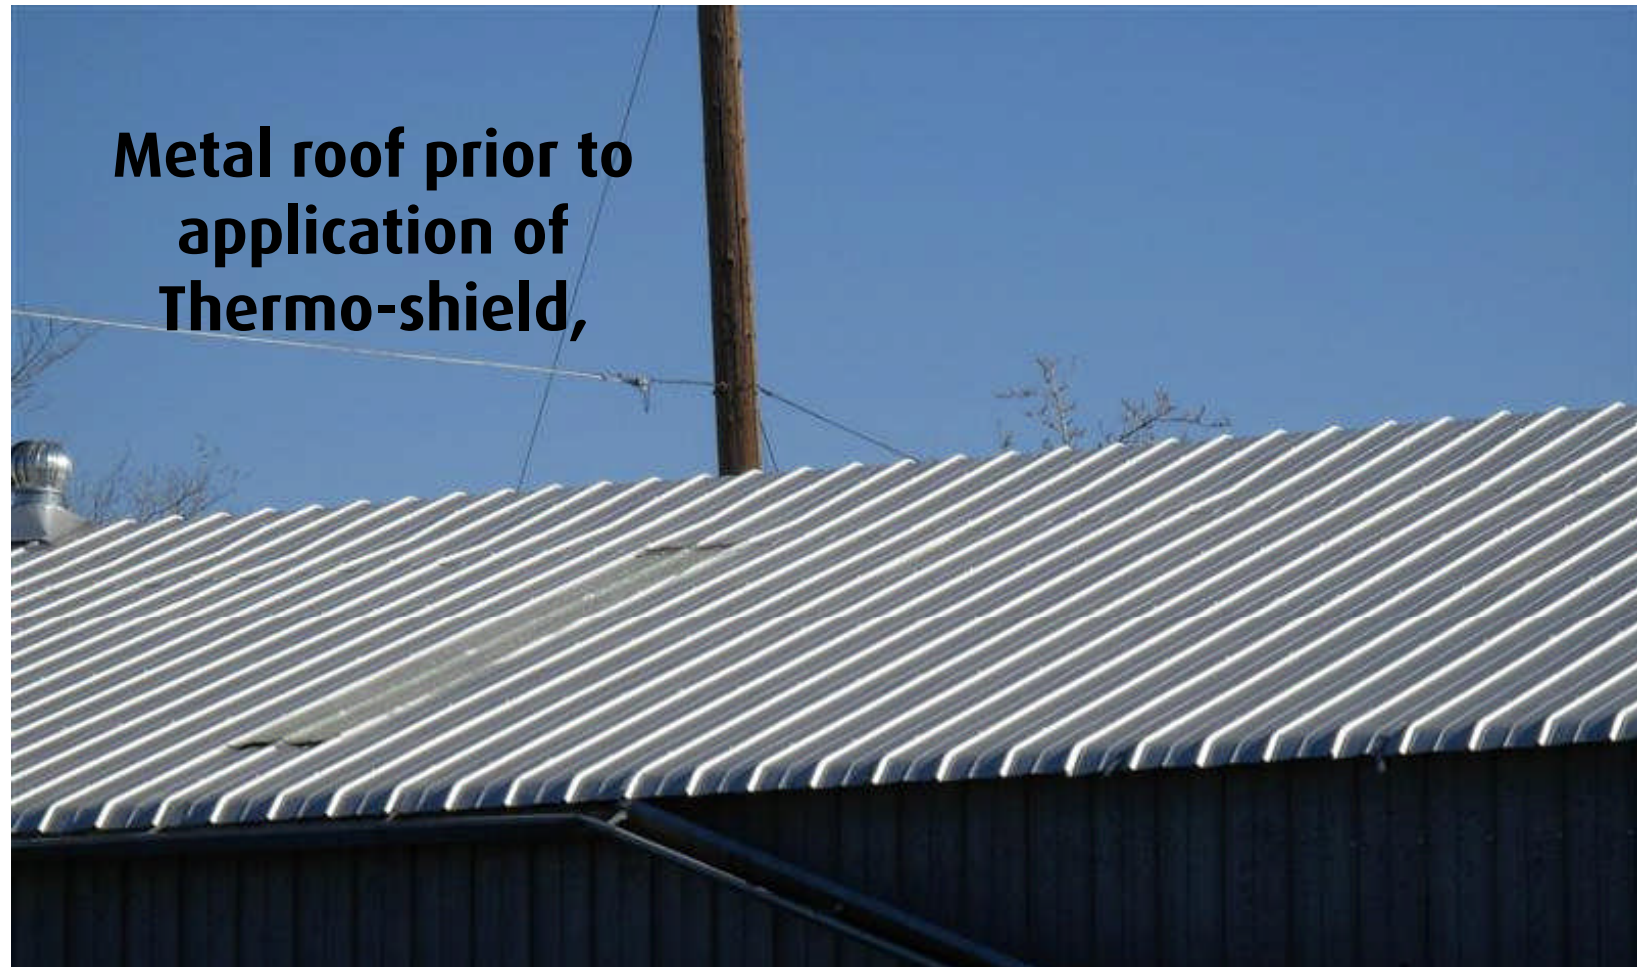
**The Reno area dealer who applied this project measured air temps and attic temps, for before and after tracking, and for his own peace of mind.
(It was his first project)**

New Thermo-shield Roof applied to building. The week of application the air temperatures were in the low 90's and attic temps were over 150 degrees. After application the temperature in the attic was 99 degrees, just a few degrees warmer than the air temperature. Constant checking during the summer shows the attic temps never rise over 5 degrees of air temps.

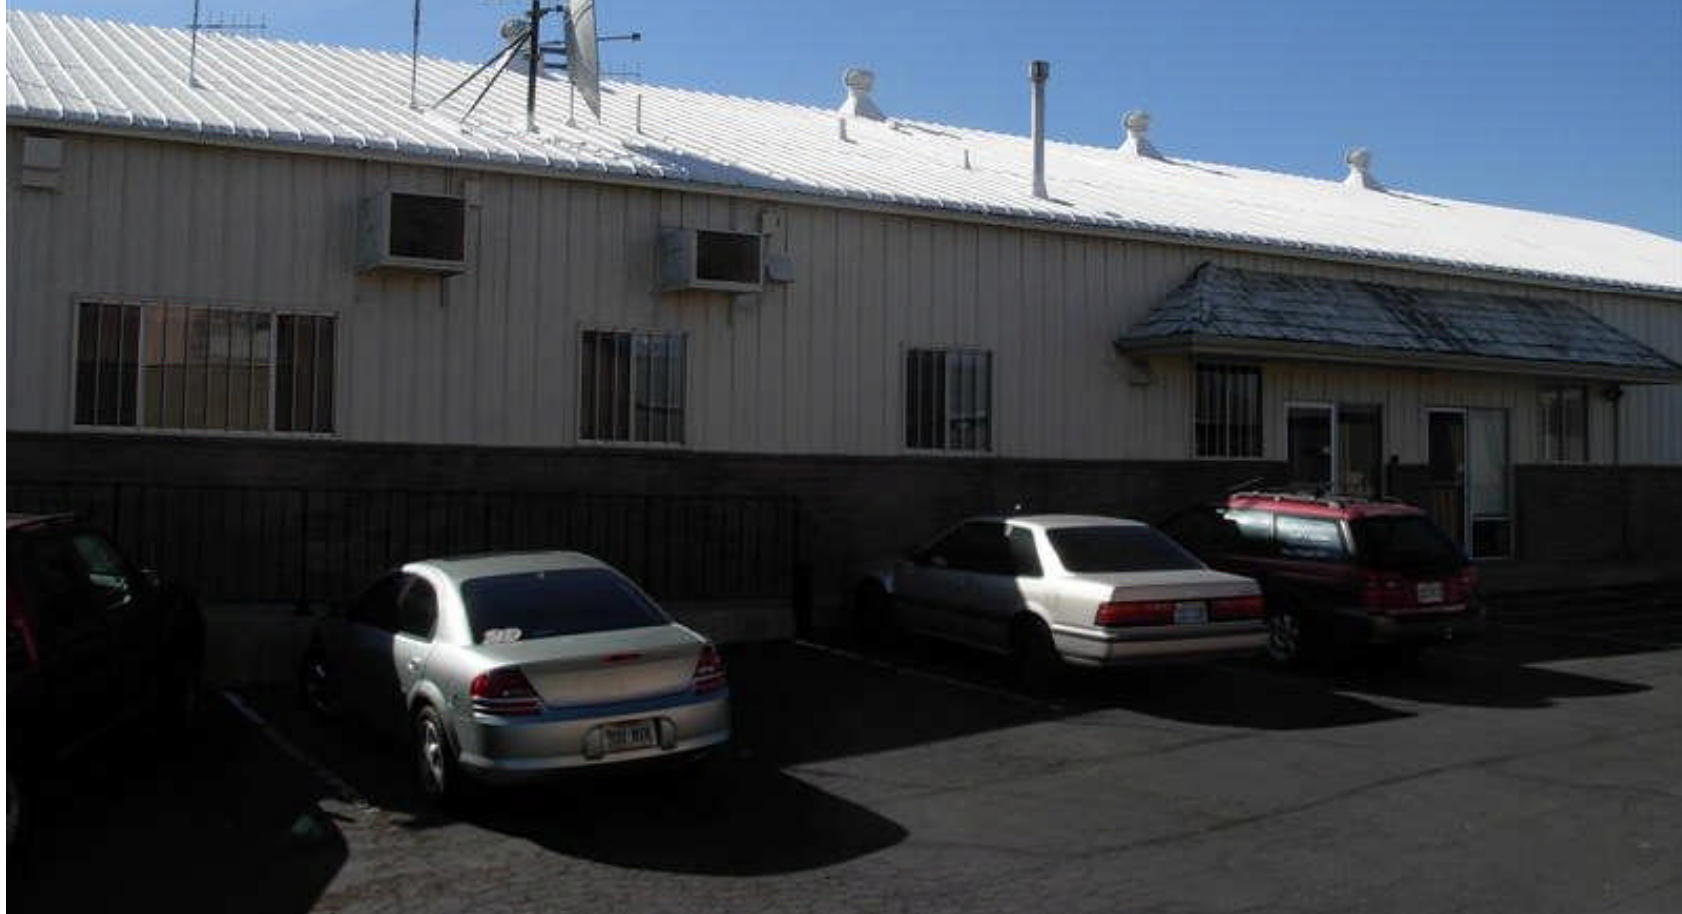
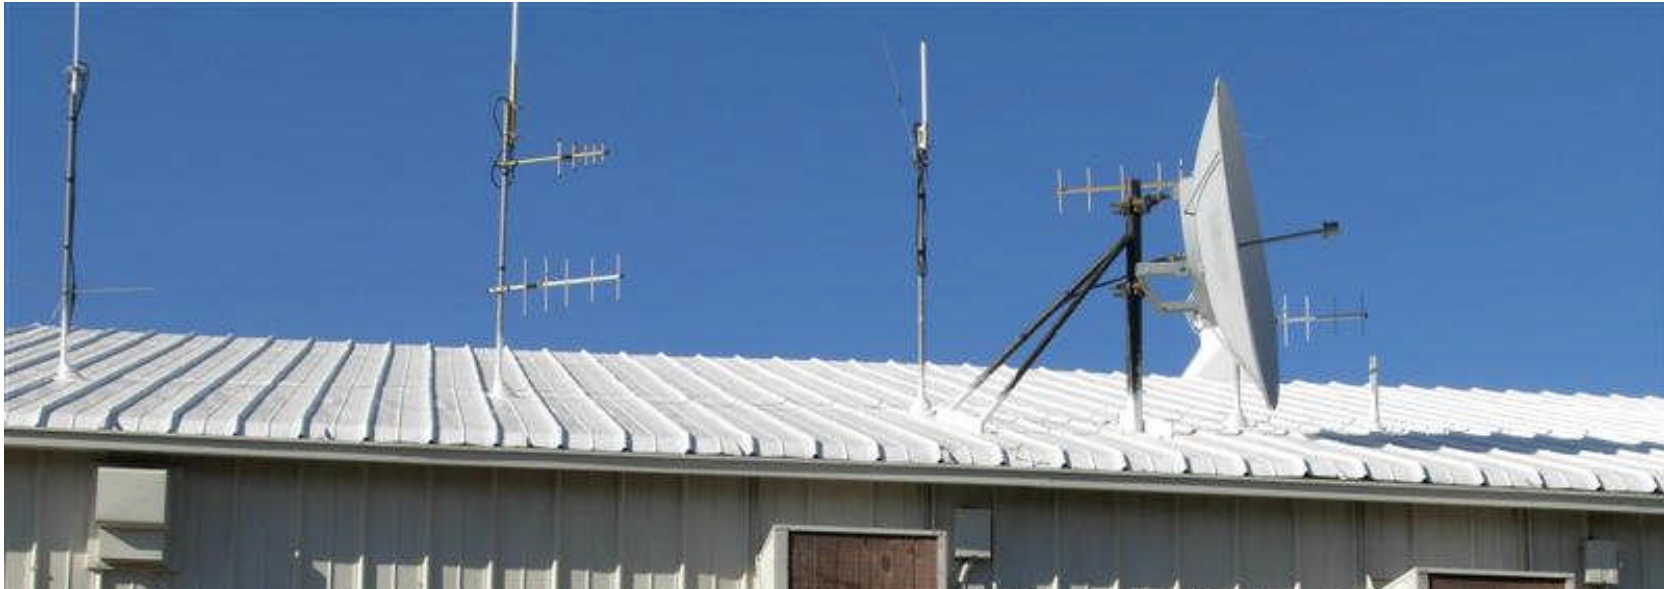
As a side note I always try to coat the entire pipe, jack, or flashing. This restores, protects, and beautifies everything on the roof and gives a wonderful, clean finish look that you do not see on this example with the black and silver pipes
