Kay's home in Las Vegas is getting a new Thermo-shield Roof. A Solar Difference, a local roofing contractor was chosen to do the installation.

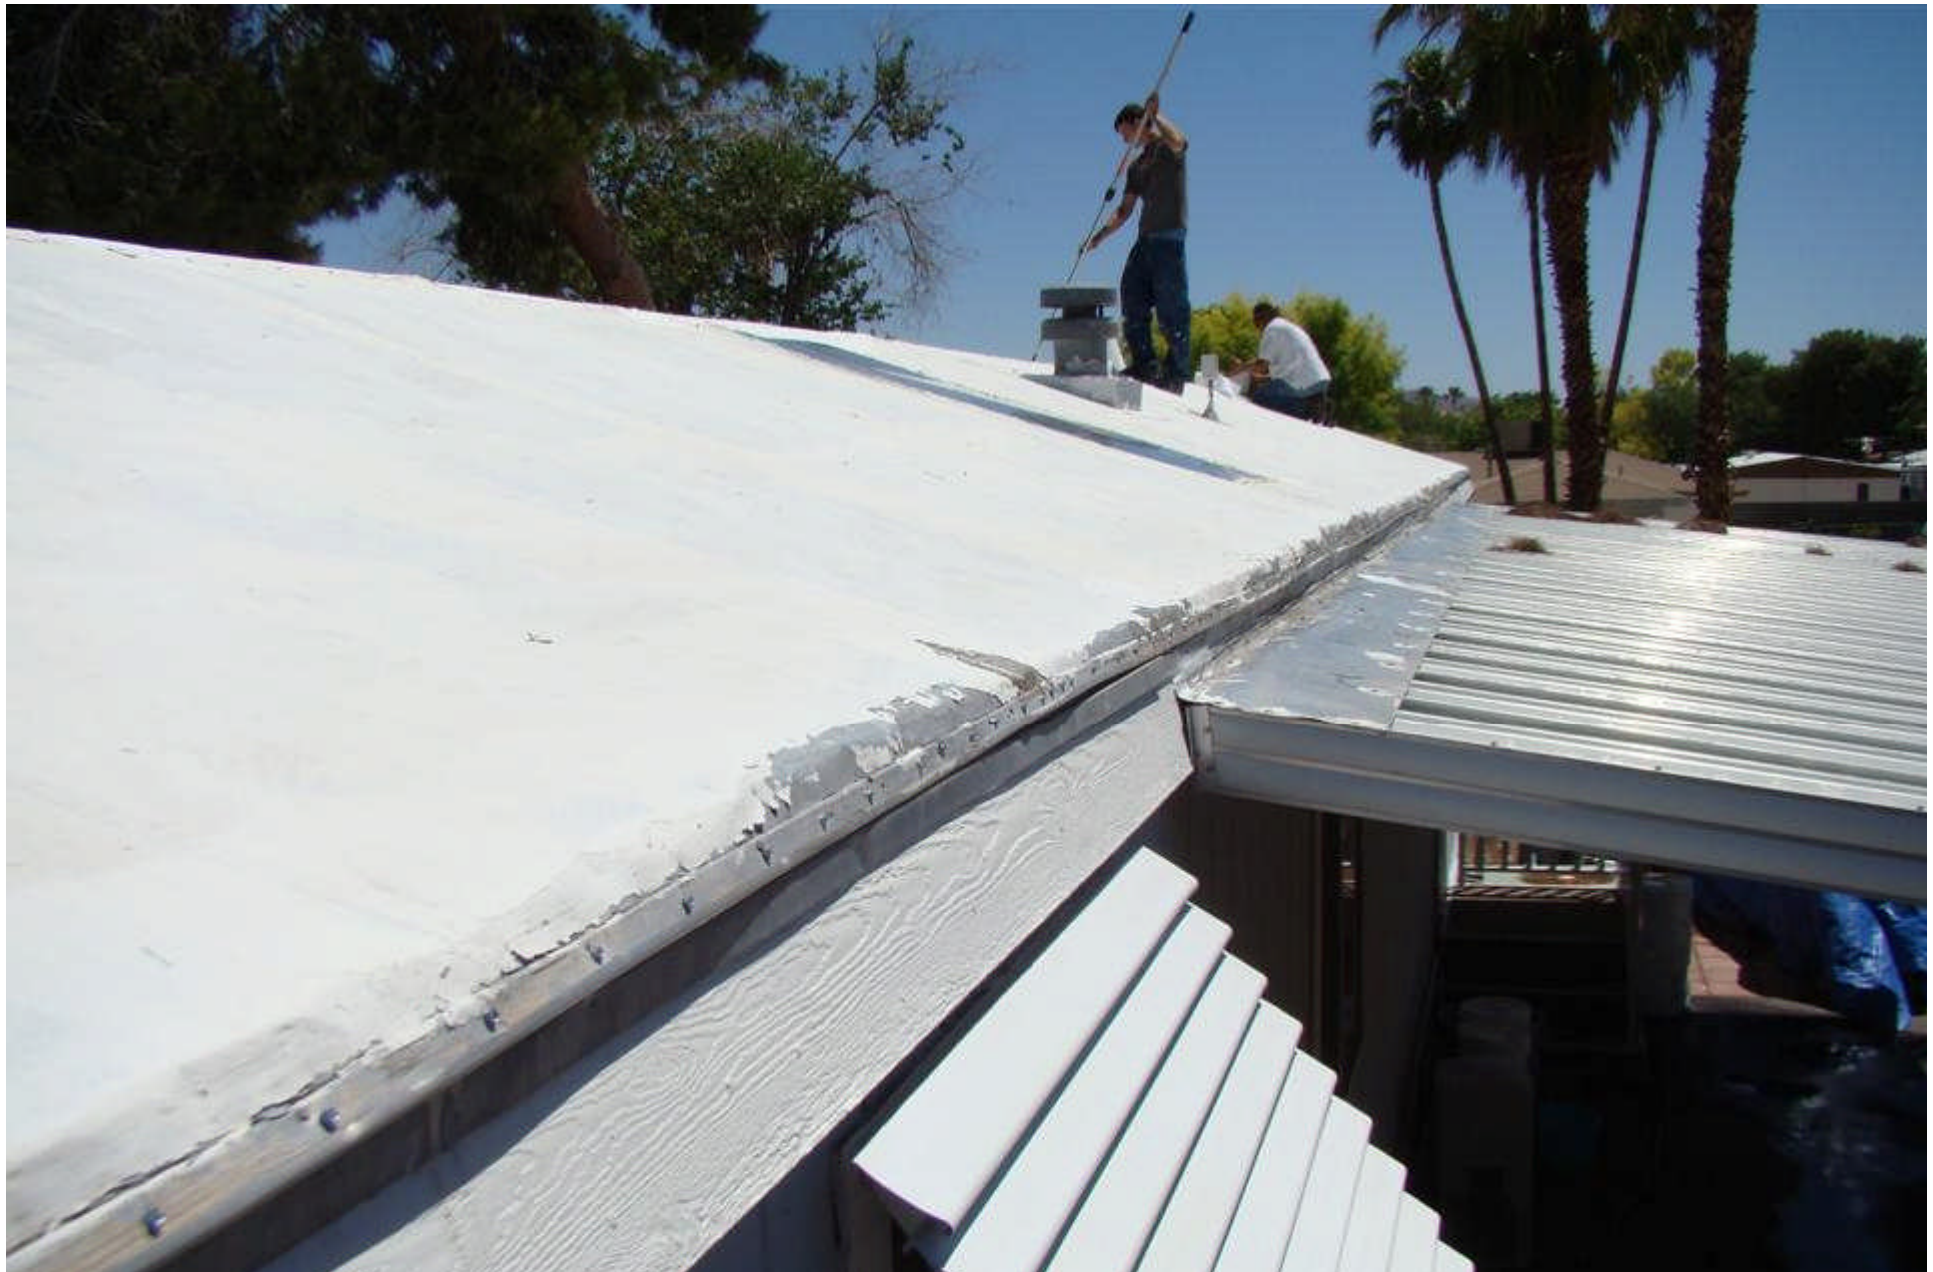
Loose fasteners have been replaced on bottom edge and over entire roof. Notice how previous roof coating has failed and peeled off of bottom edge, the place where you need it the most. (this other coating has been on less than 2 years)

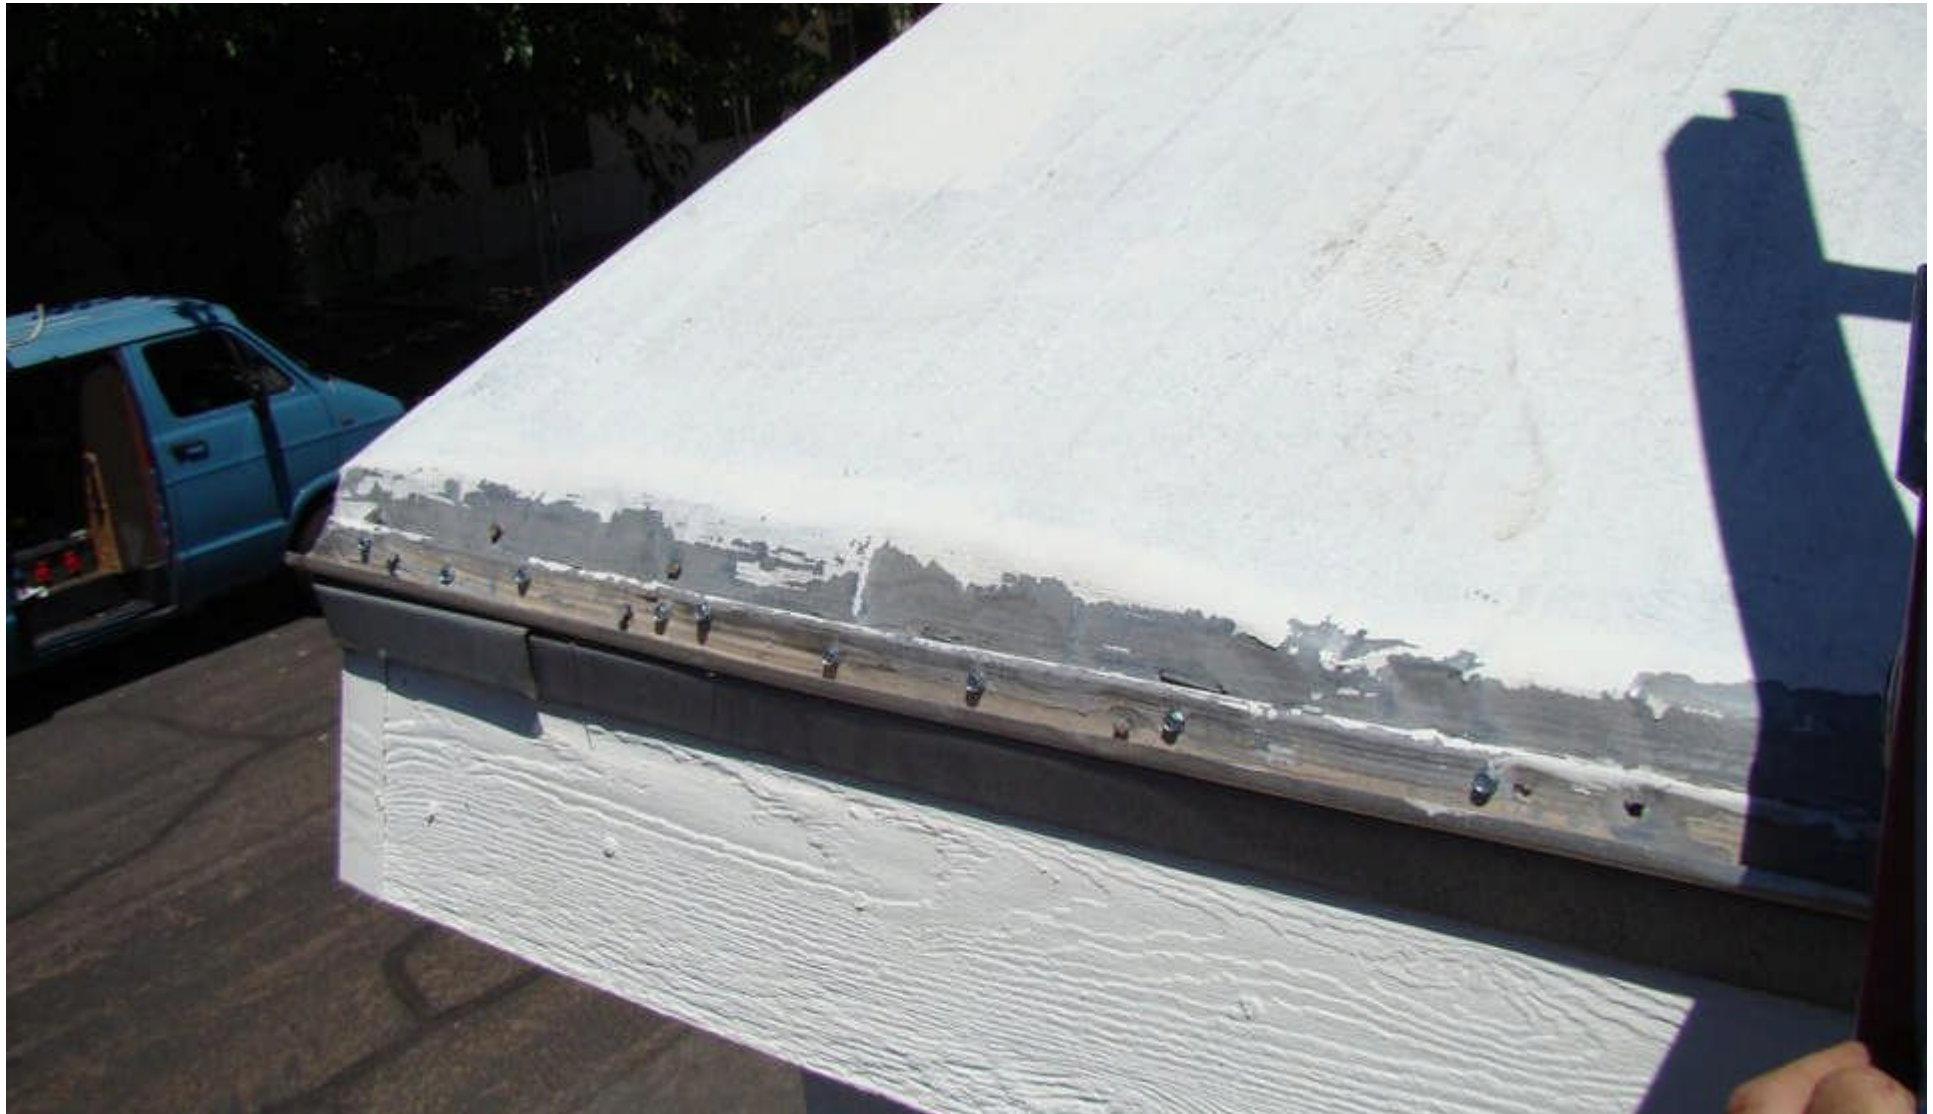
**Pol e force fabric over
edge, laps and exposed
fasteners on west side is
completed.**

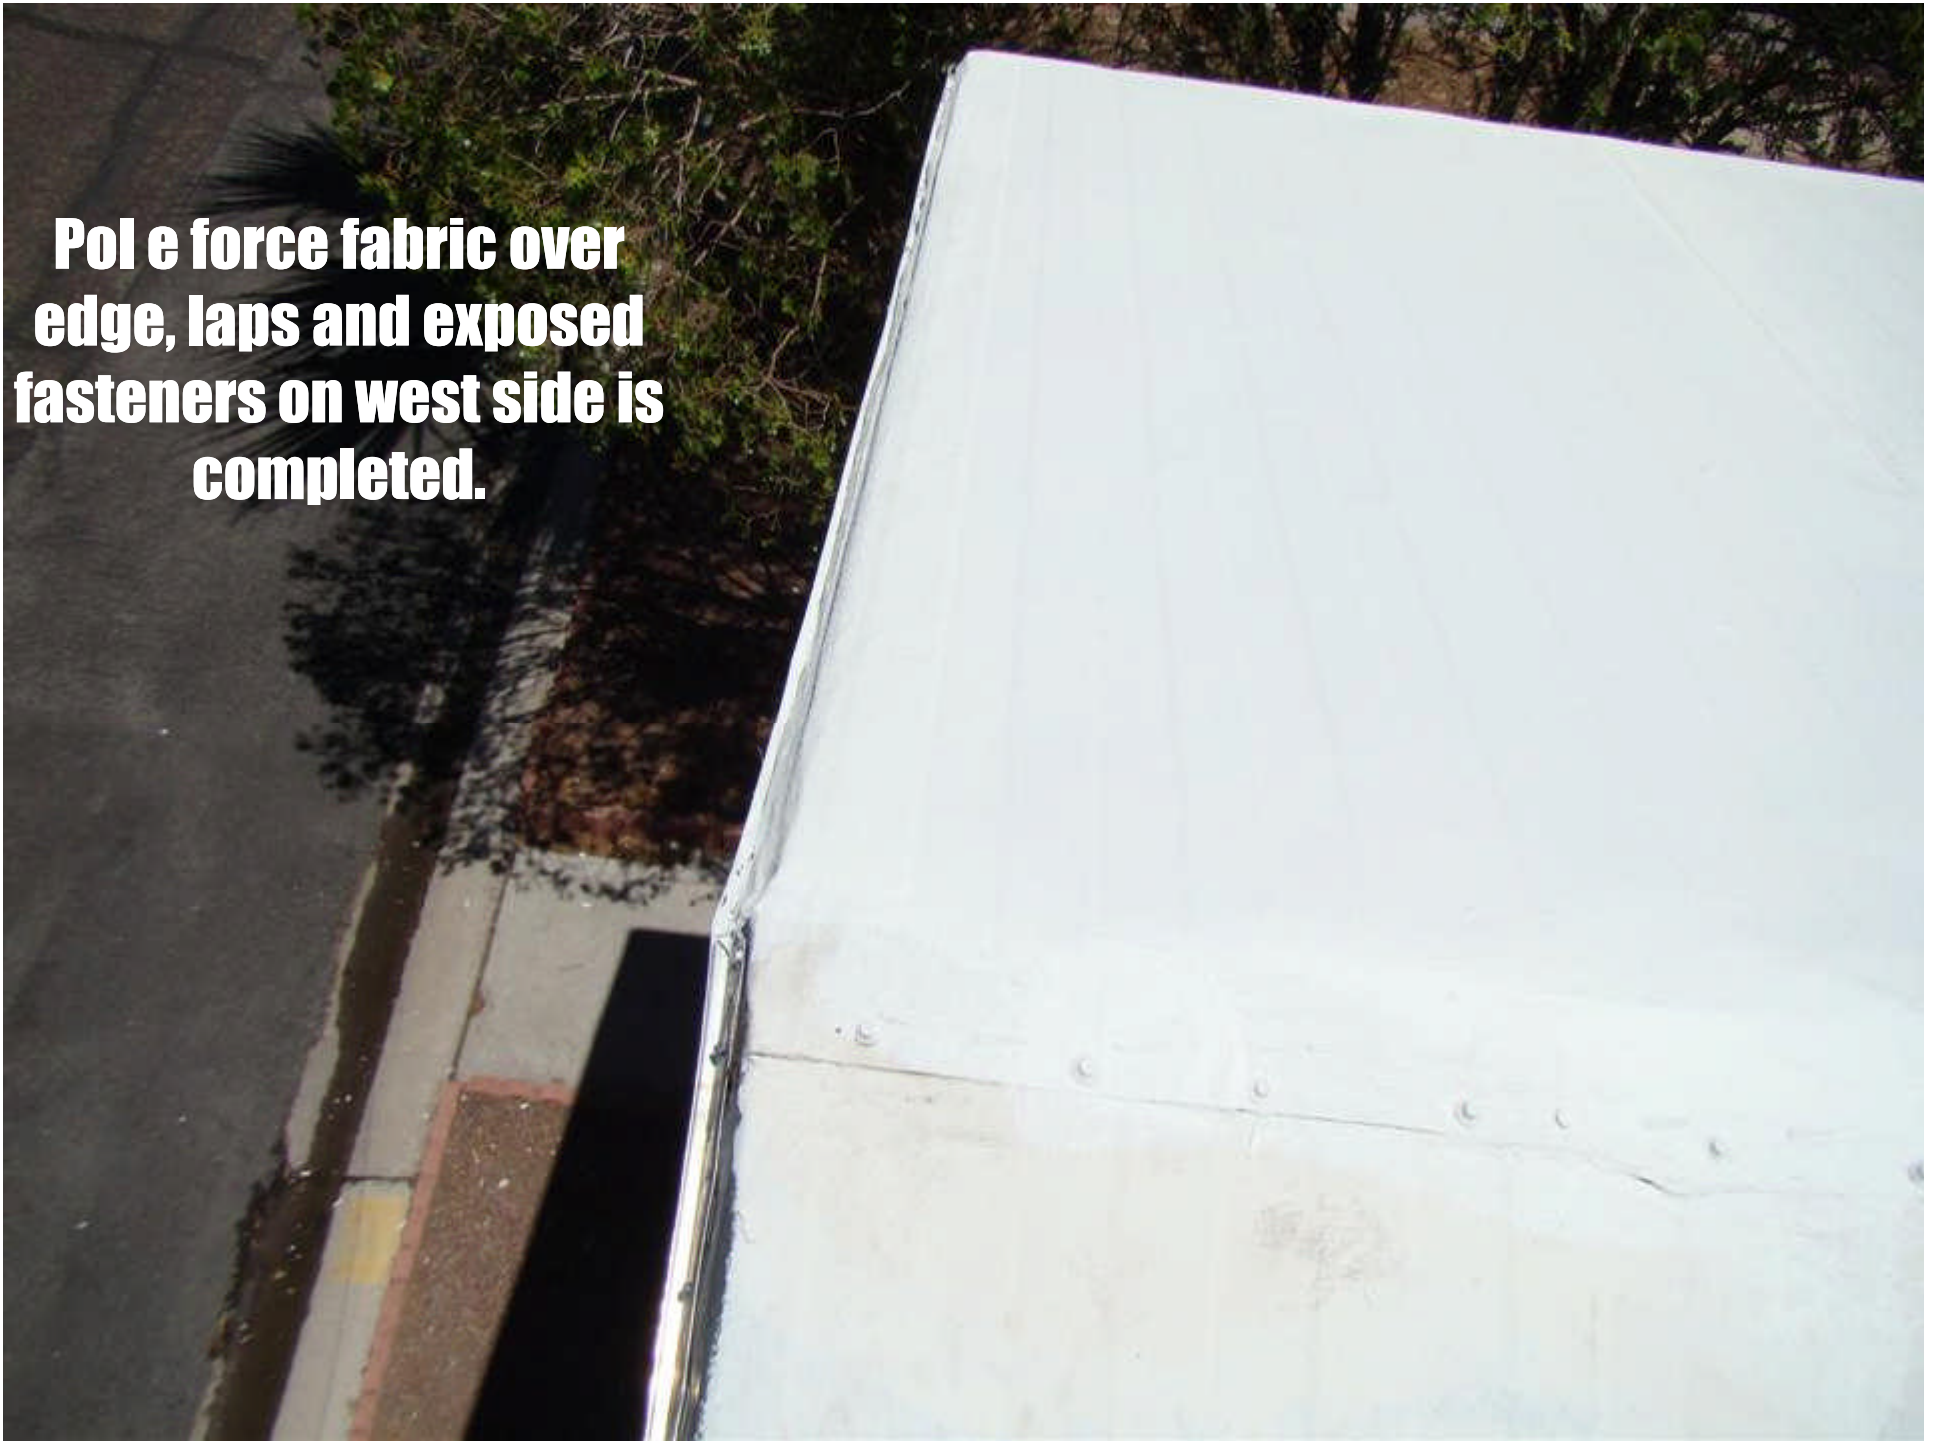
After power washing roof and installing fabric on all edges and laps the first coat of Thermo-shield is ready to apply

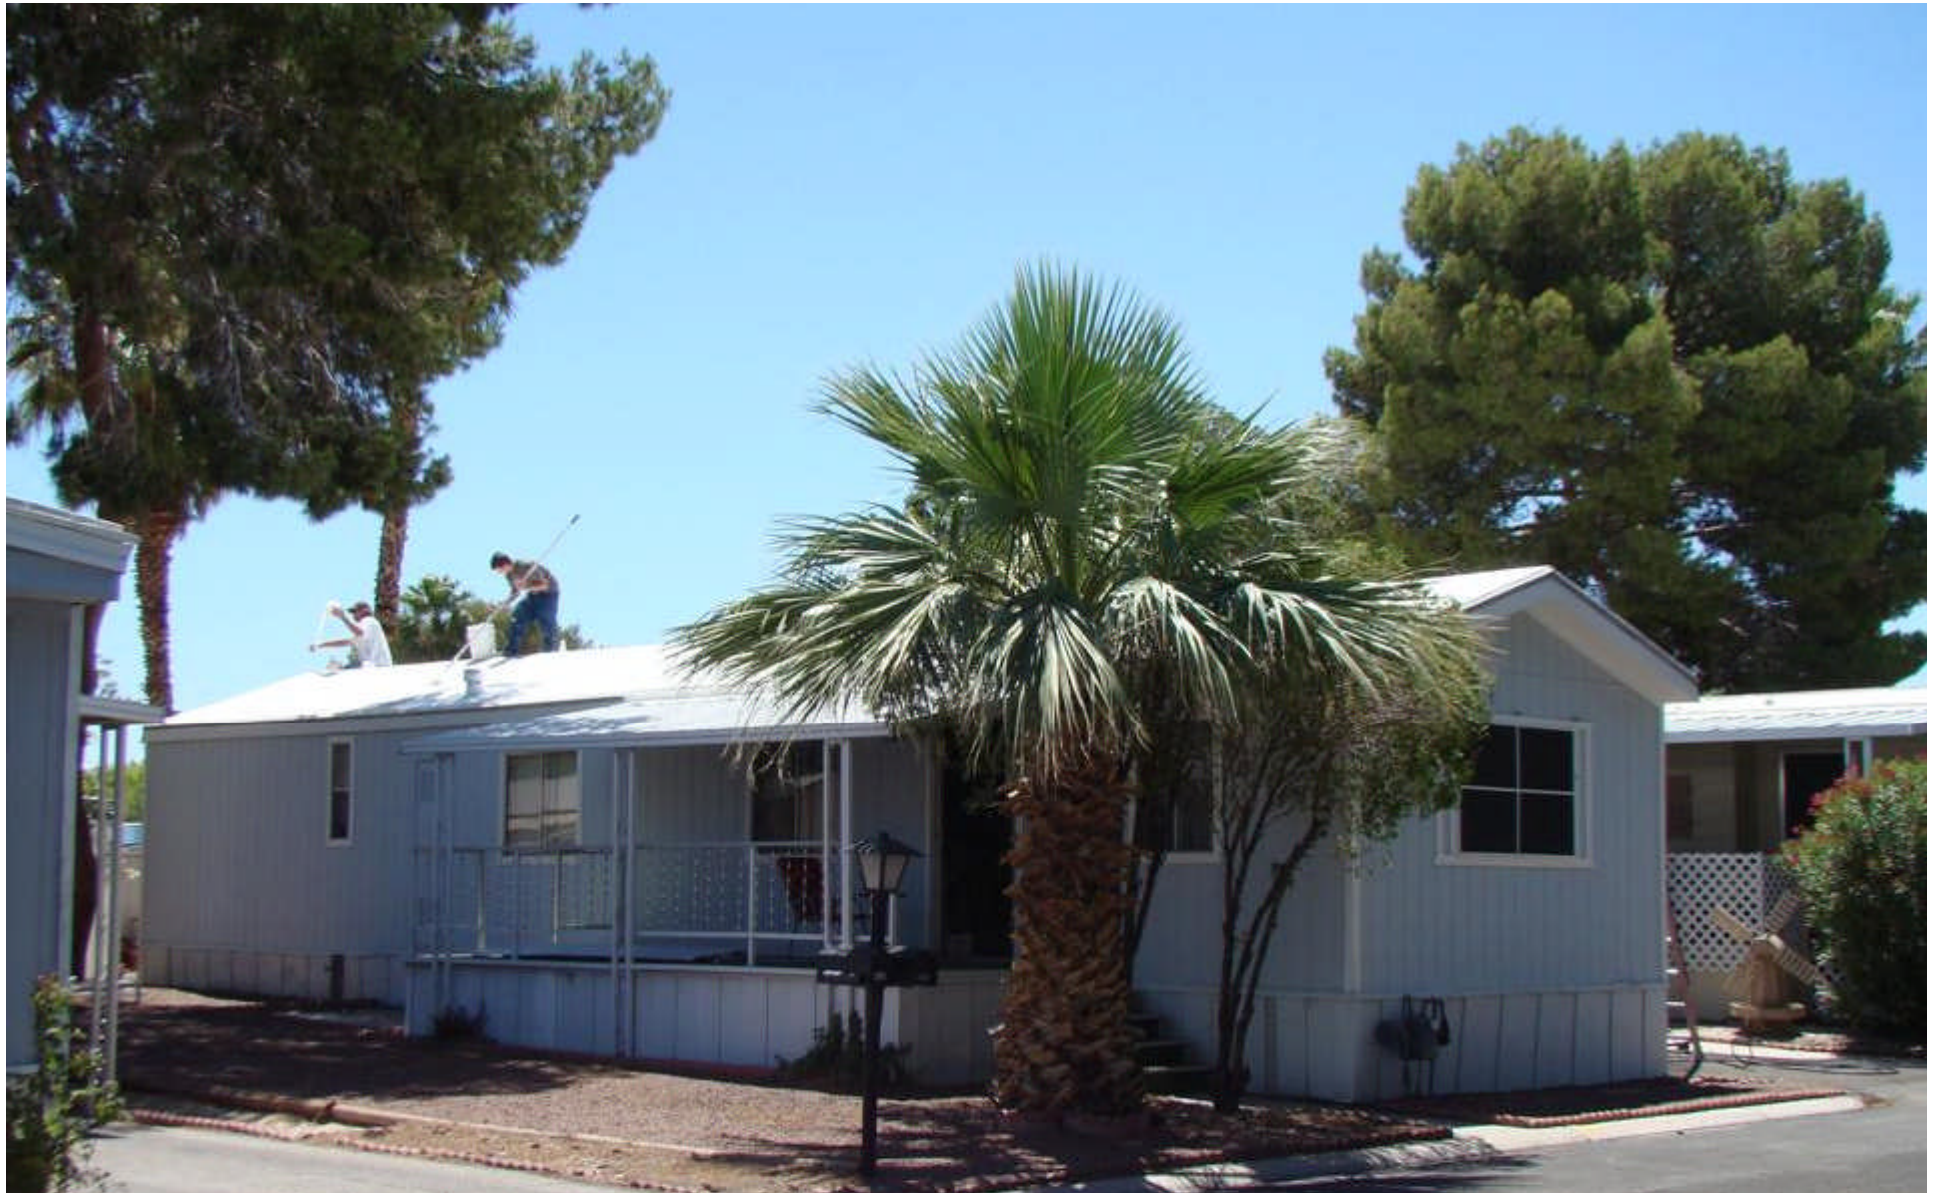
One worker is installing Pol e force fabric on east side edges, laps, and flashings. The other is applying first coat on west side with a 9" roller and extension handle

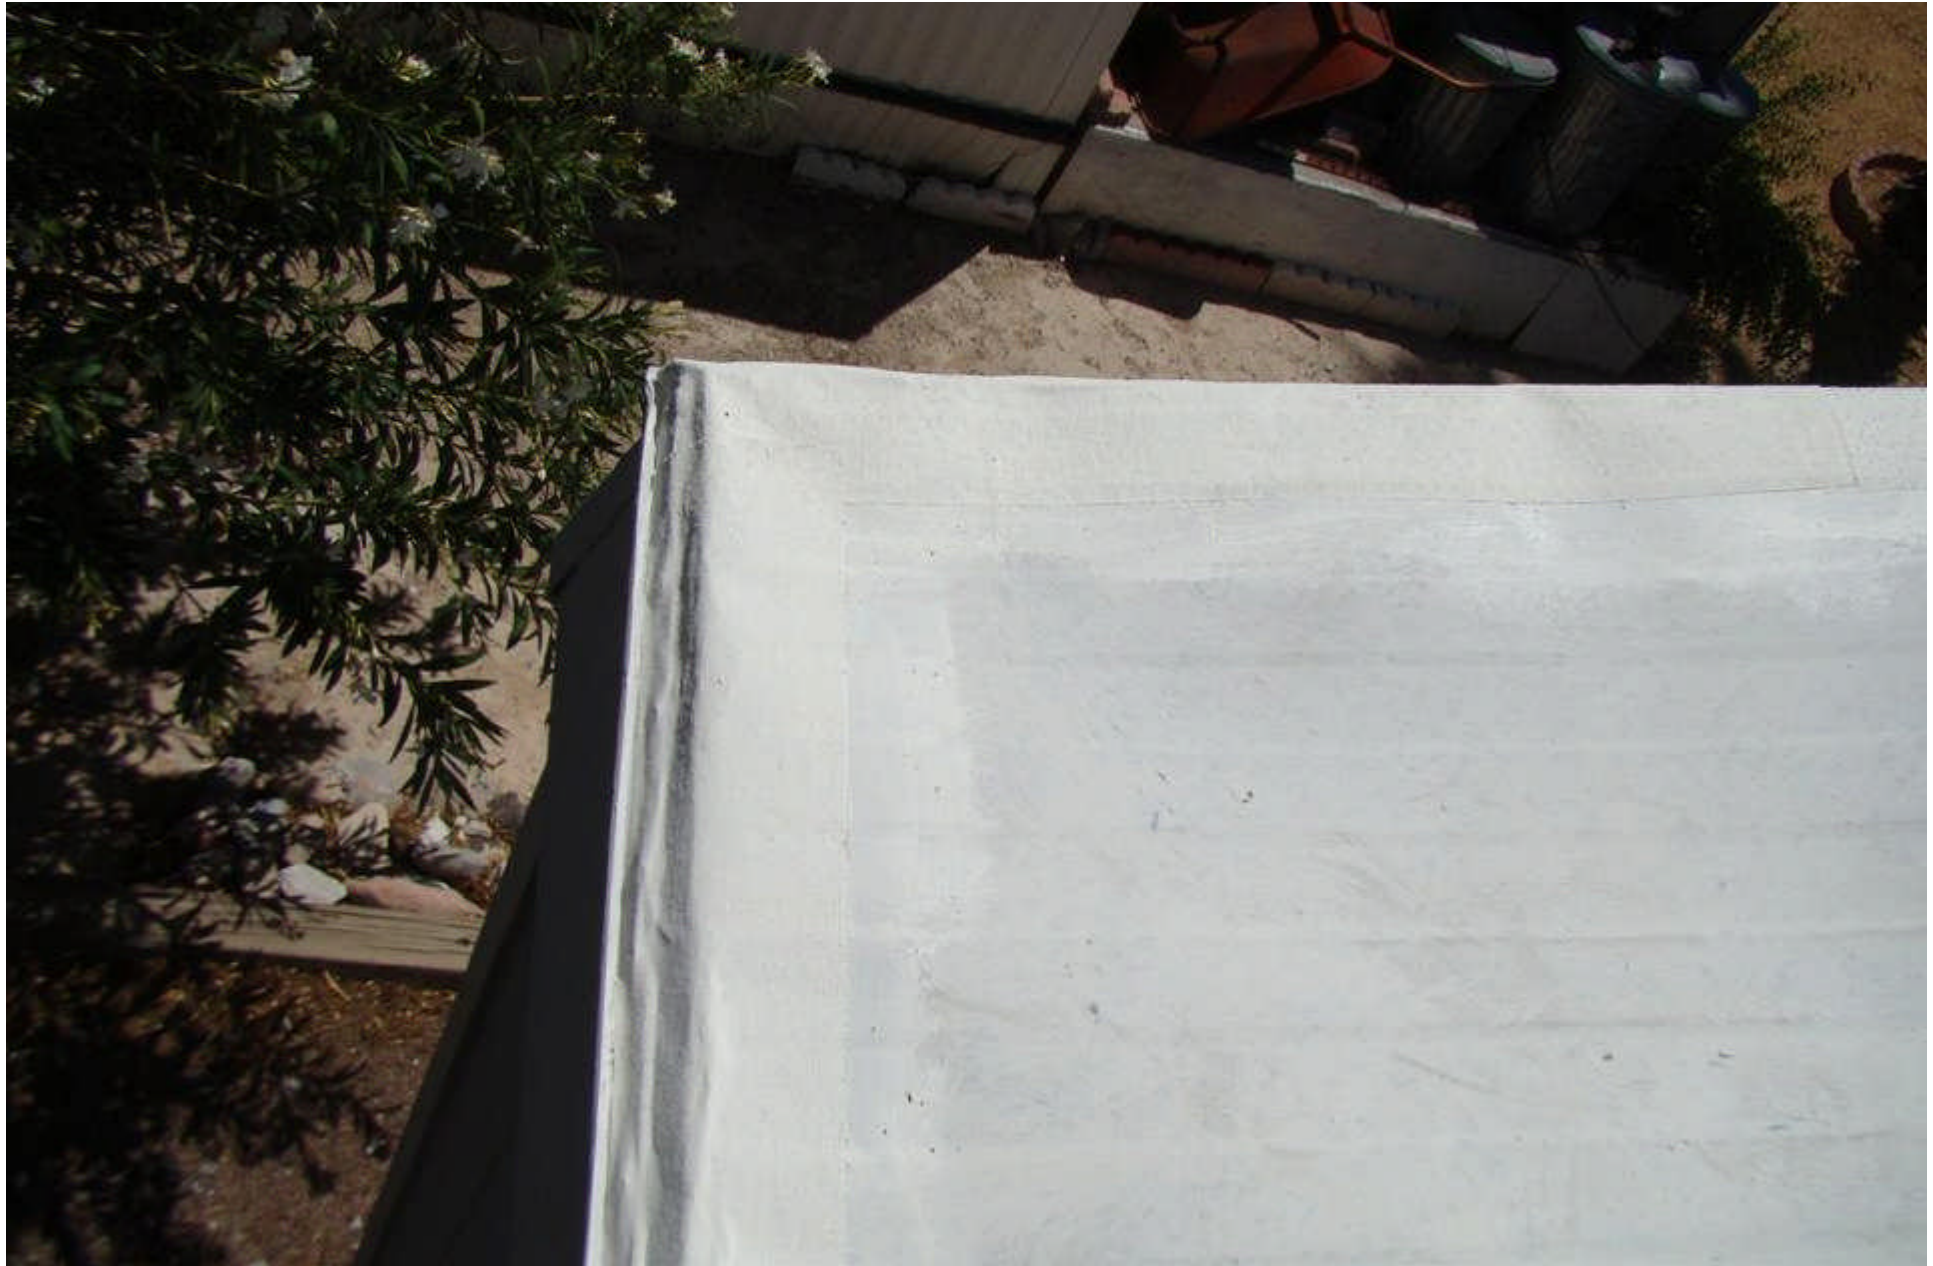
The fasteners and troublesome edge detail are covered with Thermo-shield and Pol e force fabric before first coat is applied

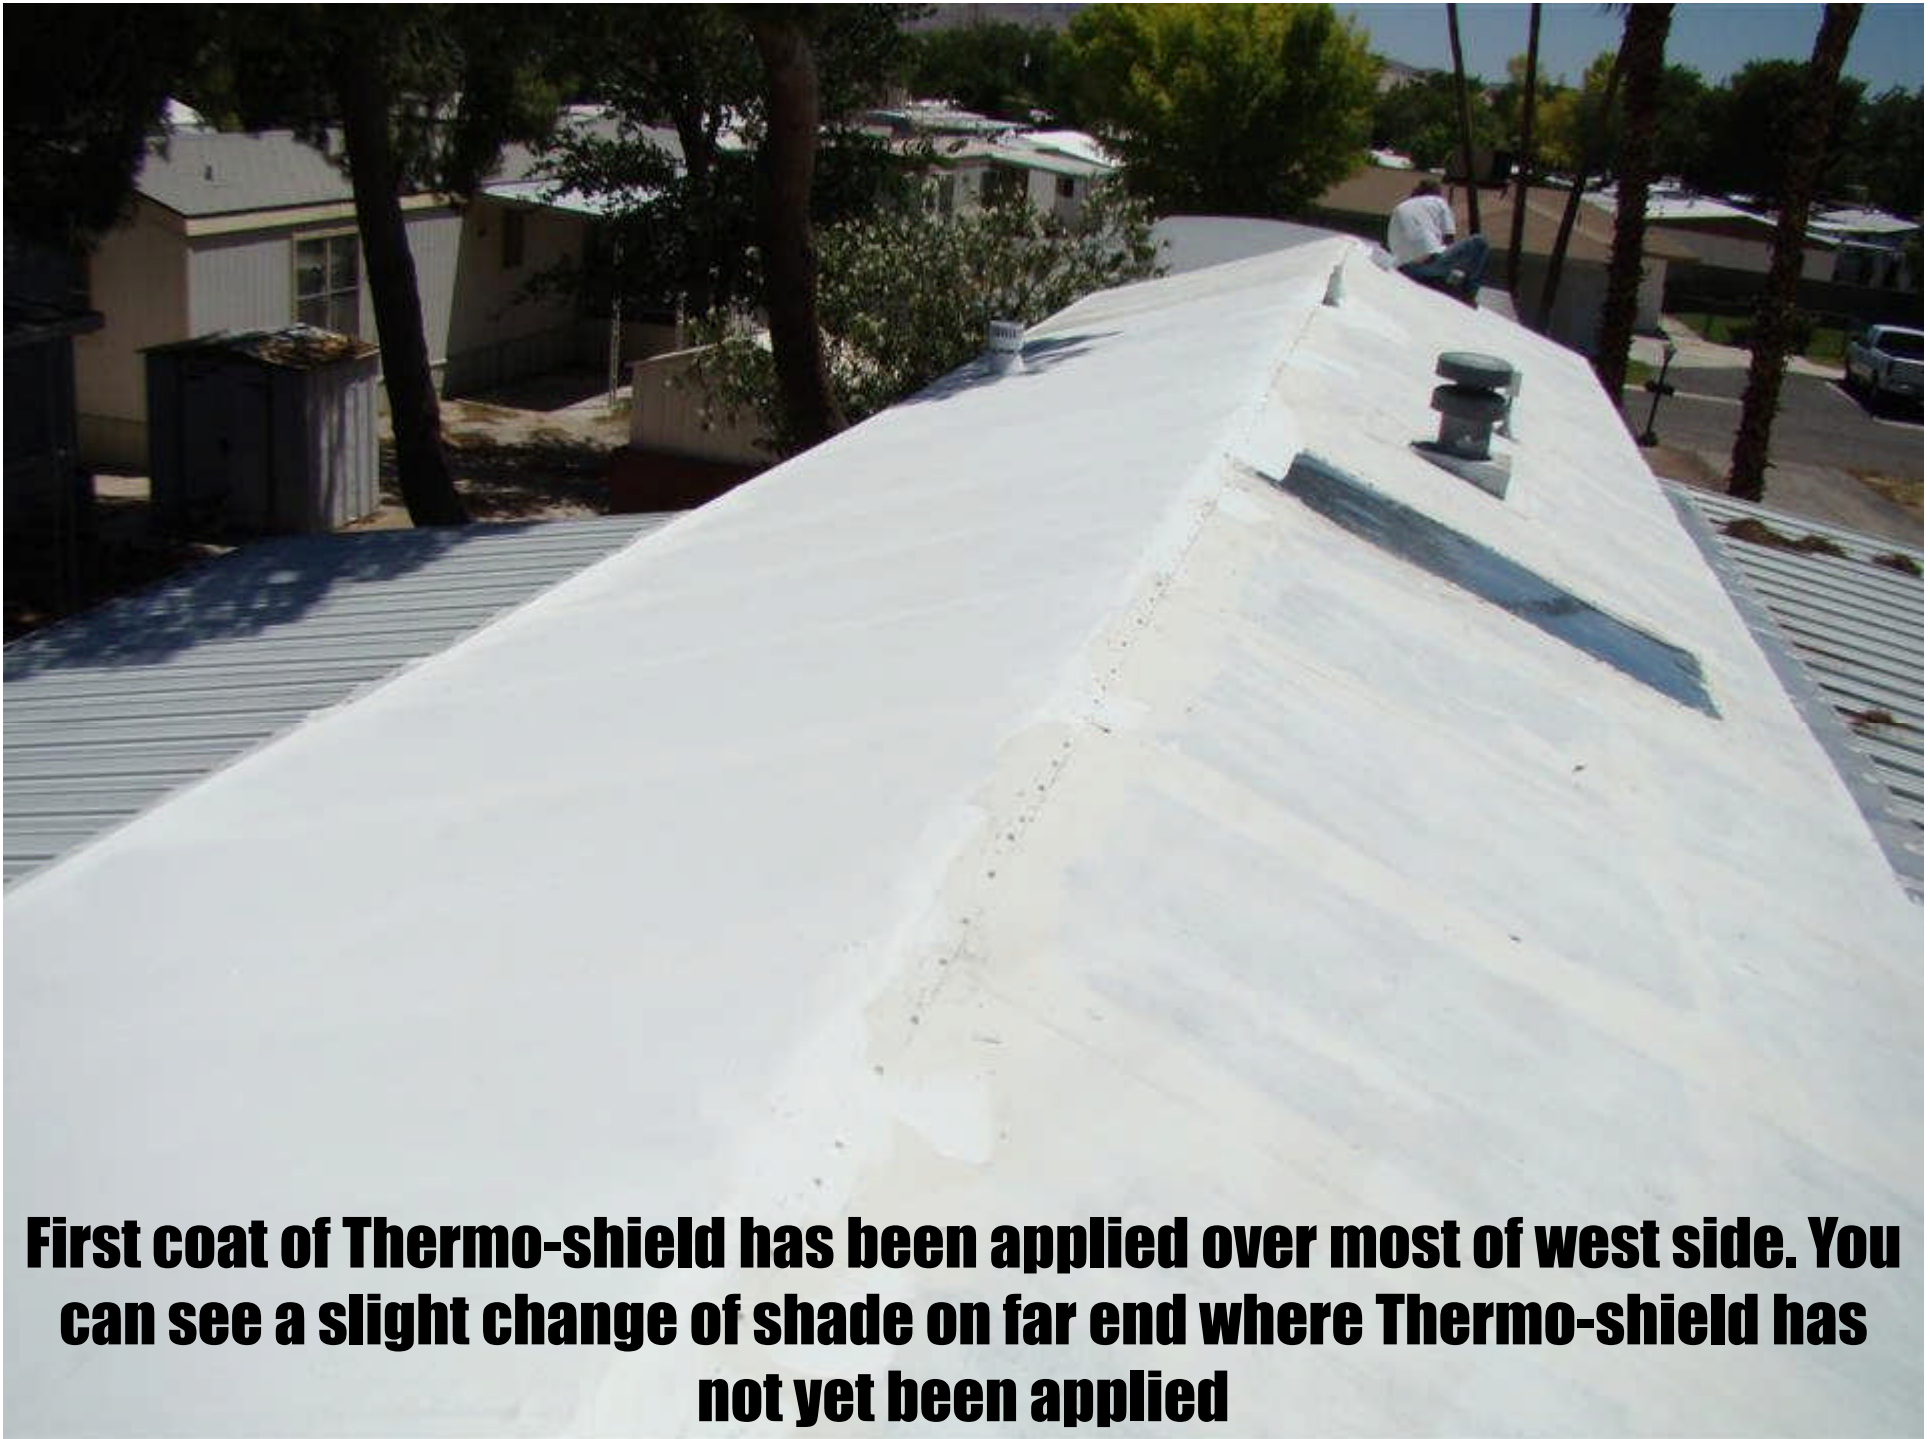
First coat of Thermo-shield has been applied over most of west side. You can see a slight change of shade on far end where Thermo-shield has not yet been applied

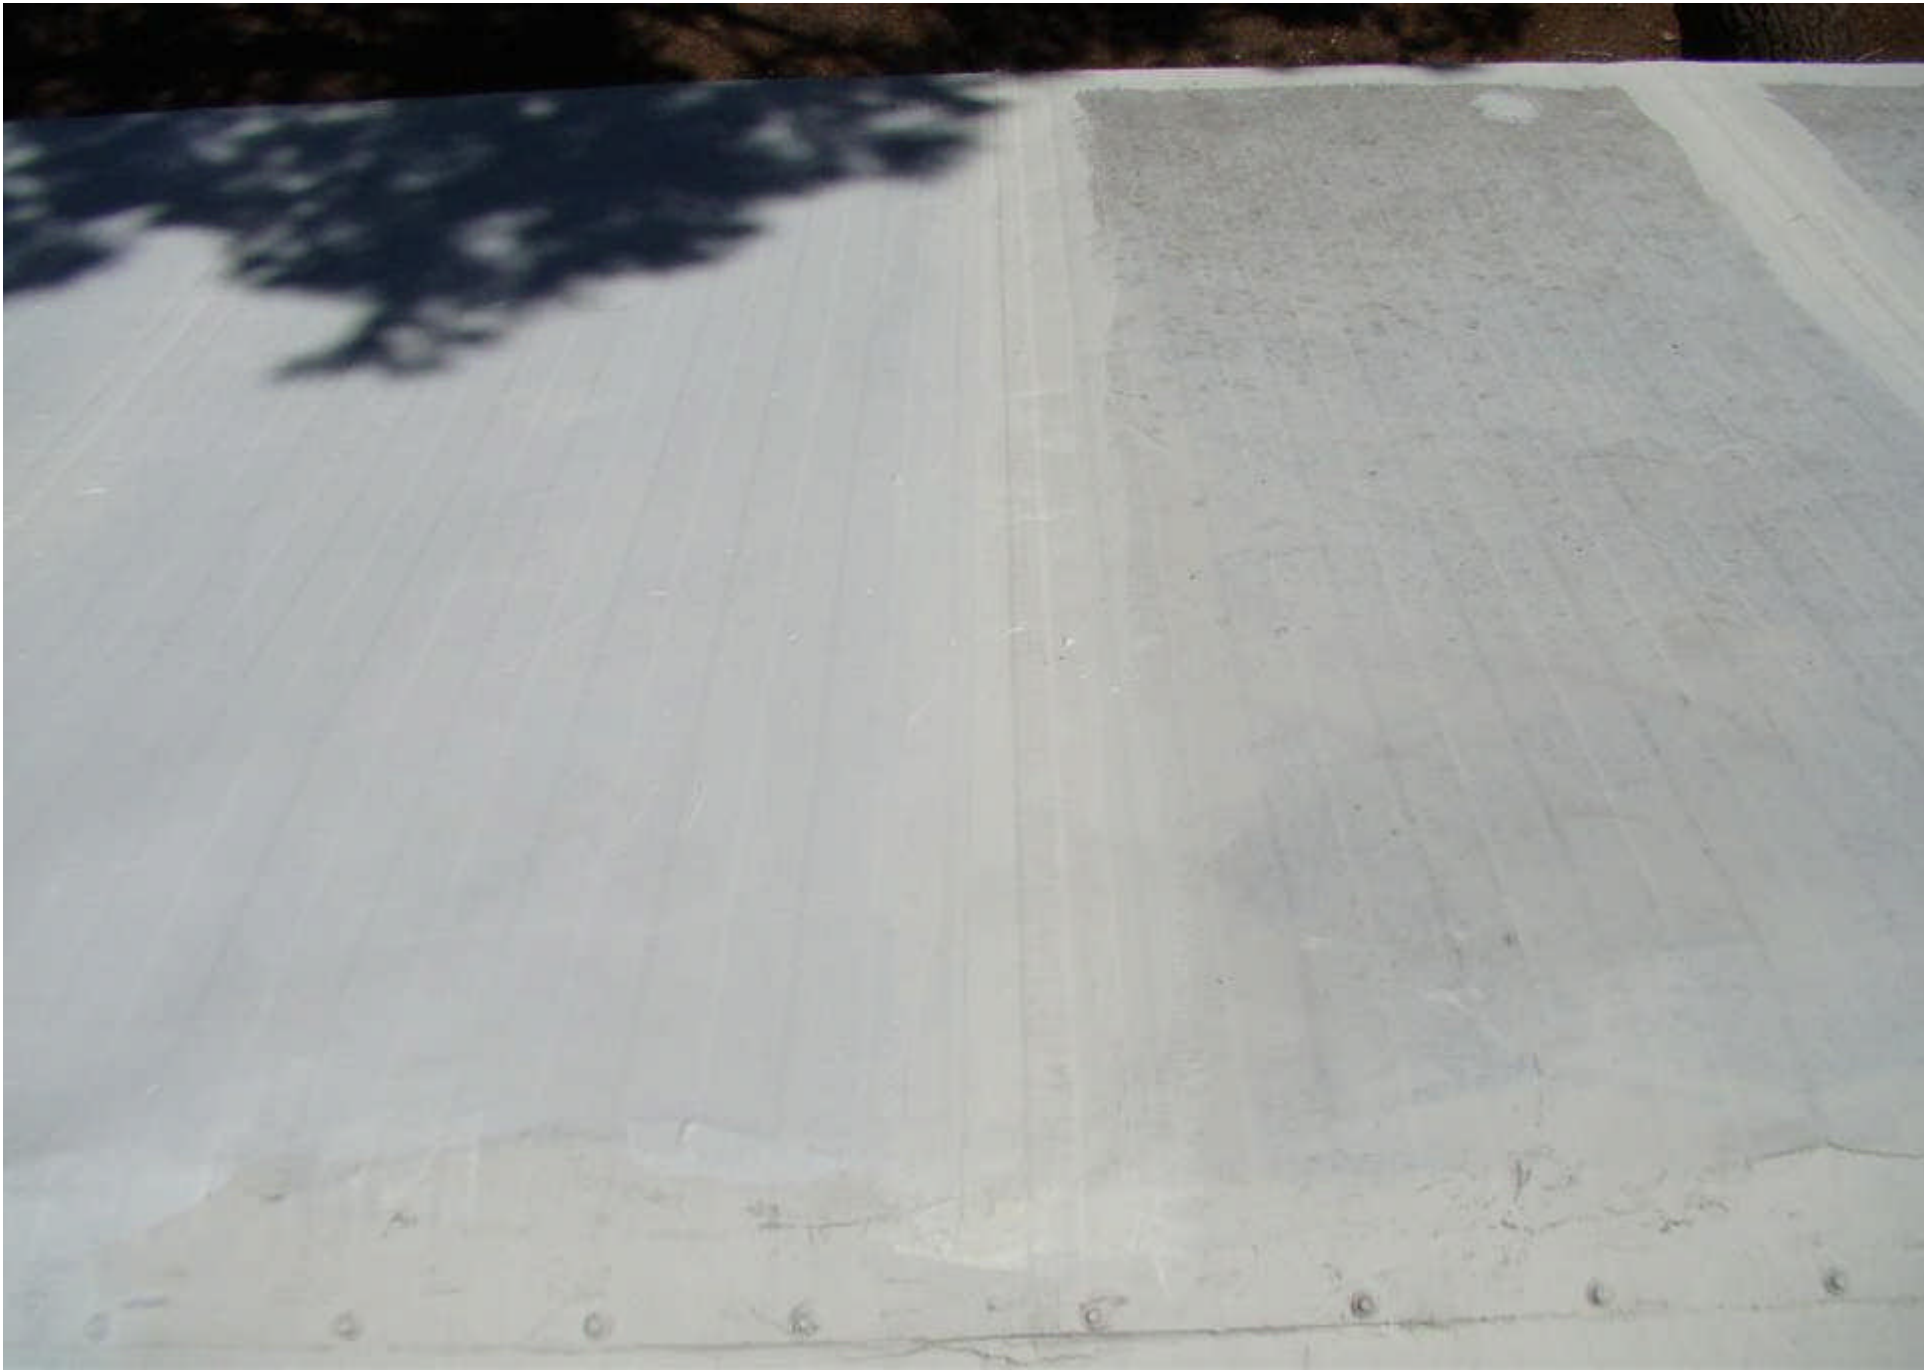
Taking temperature of old coating. Air temperature was about 85 and this side of roof is not even the direct exposure side. There is a 27 degree heat gain here.

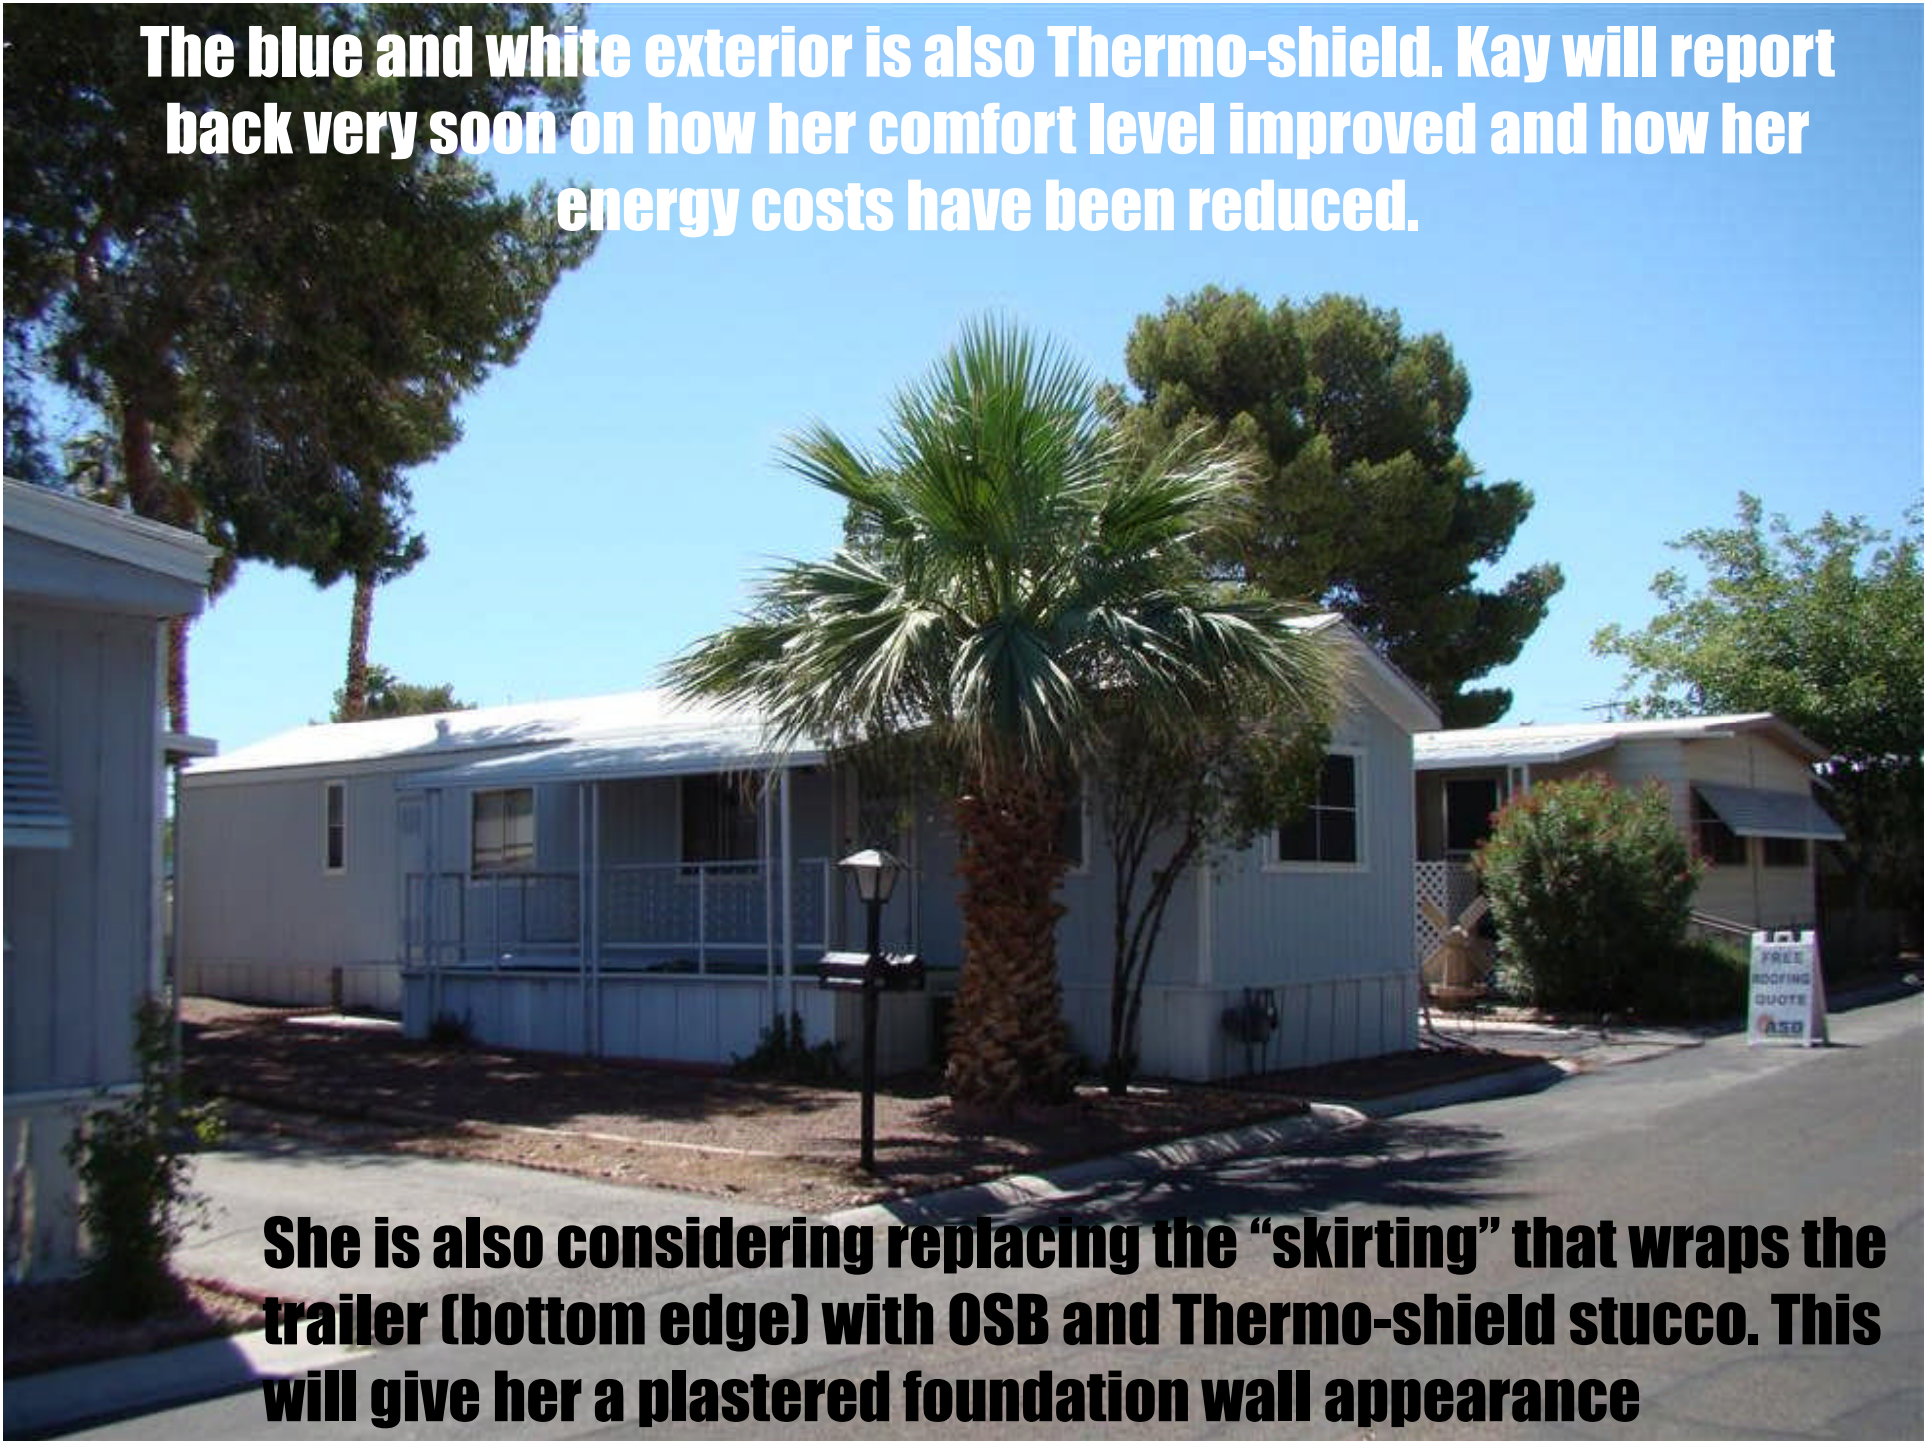
The blue and white exterior is also Thermo-shield. Kay will report back very soon on how her comfort level improved and how her energy costs have been reduced.

She is also considering replacing the “skirting” that wraps the trailer (bottom edge) with OSB and Thermo-shield stucco. This will give her a plastered foundation wall appearance
