**Leaks were a big problem on this 9 unit apartment in Salt Lake City. Owner could not afford an entire new system but needed to stop the water from coming in, Thermo-shield to the rescue. Leaks solved and owner will finish entire system as her budget allows.**

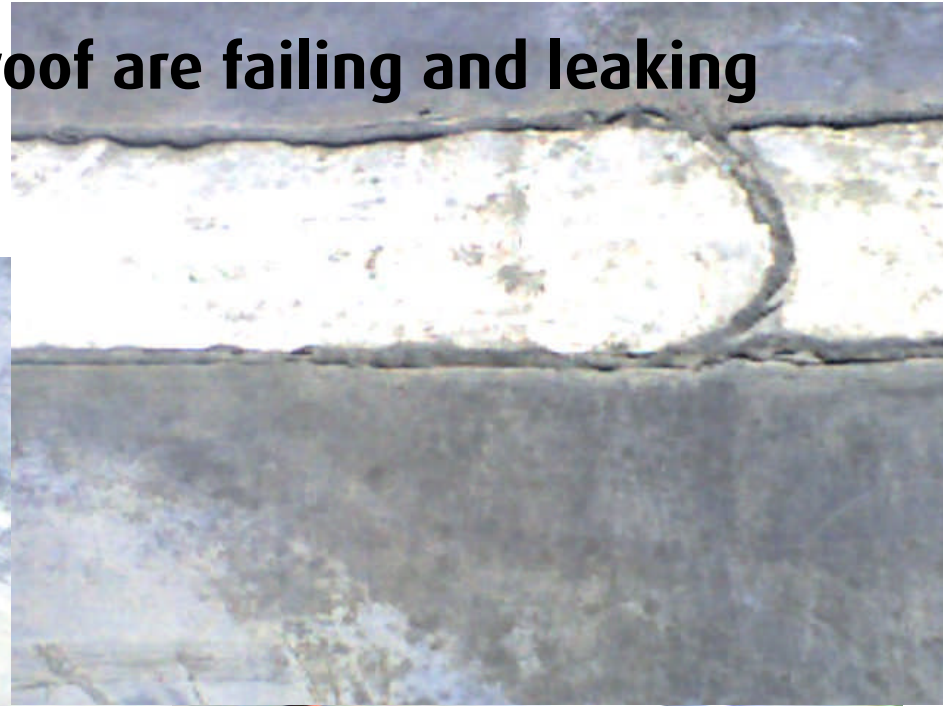
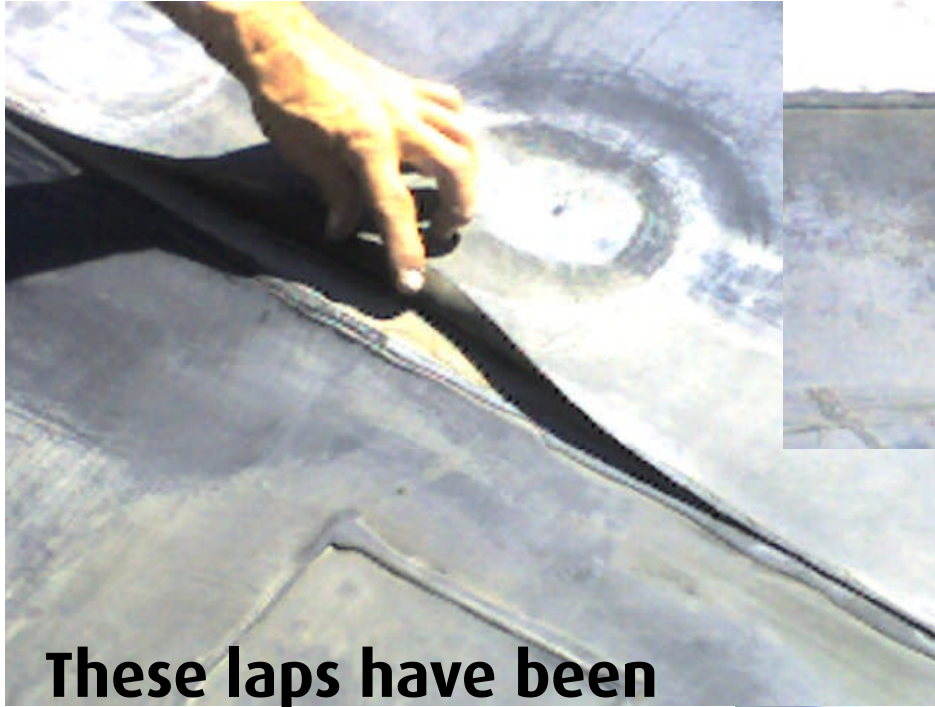
## Laps on epdm rubber roof are failing and leaking

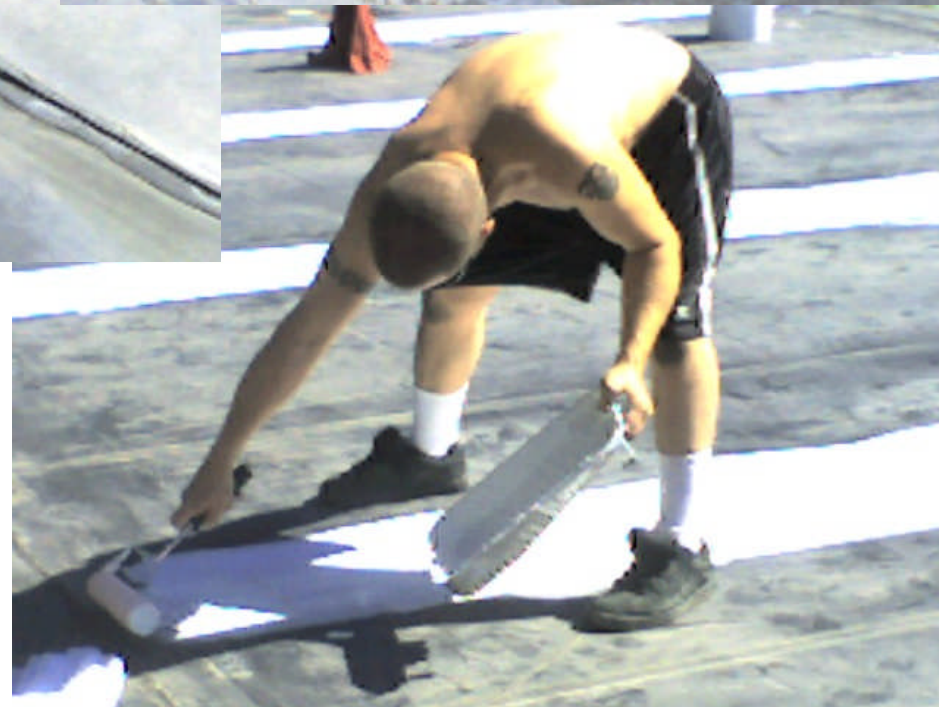
**These laps have been repaired already using white faced epdm over field laps. These repairs only held up 3 years.**
